**Watershed Protection  
Development Review**

# Aquatic Invasive Species Control Efforts in Austin, Texas

**Gulf & South Atlantic Regional Panel on  
Aquatic Invasive Species**

October 4, 2011

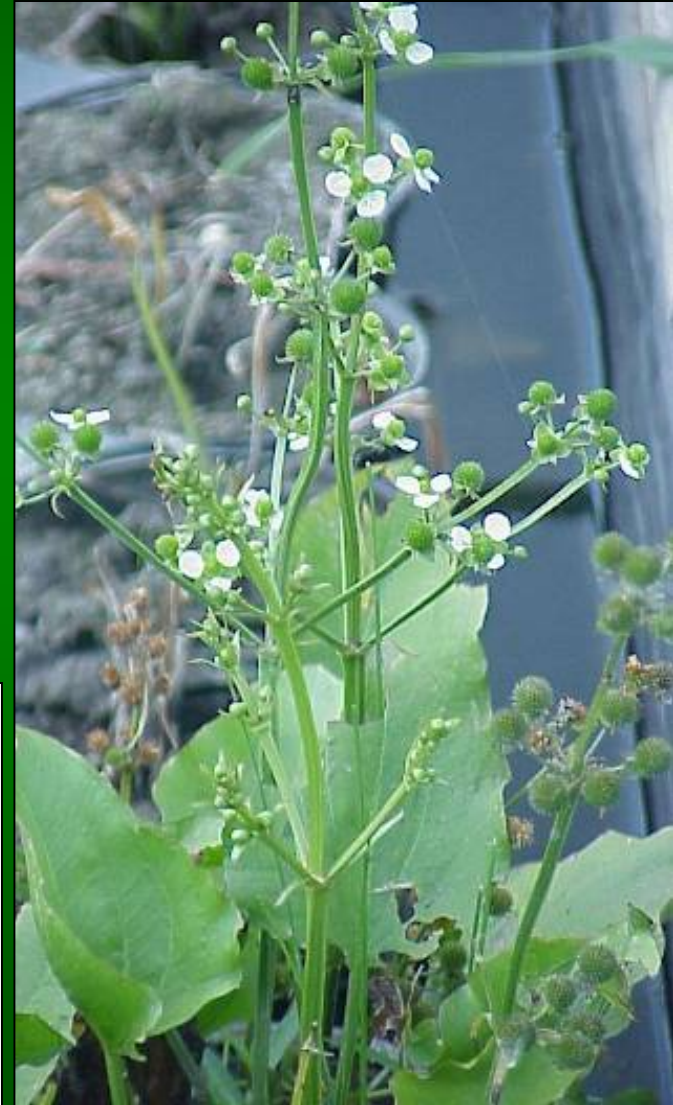
- 10 sites on each lake, now 20
- 7 species, two growth habits
  - emergent, submersed
- 1-2 ft depths
- Herbivore exclosures
  - Tray and ring cages

Built on-site  
PVC coated wire

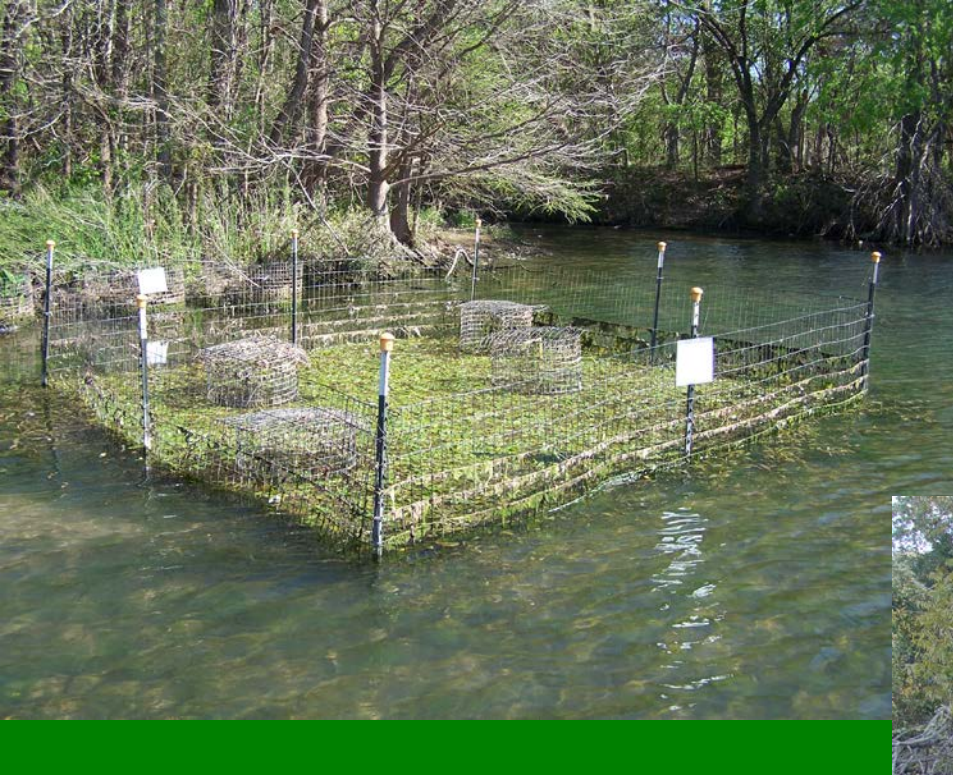
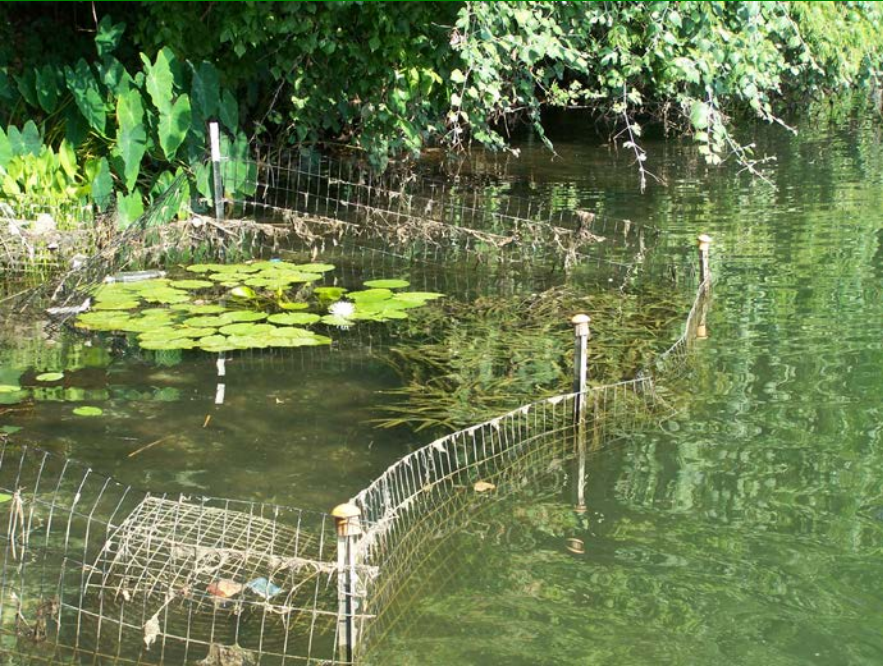
# 2009- Large Pens

Increased growth and propagule production

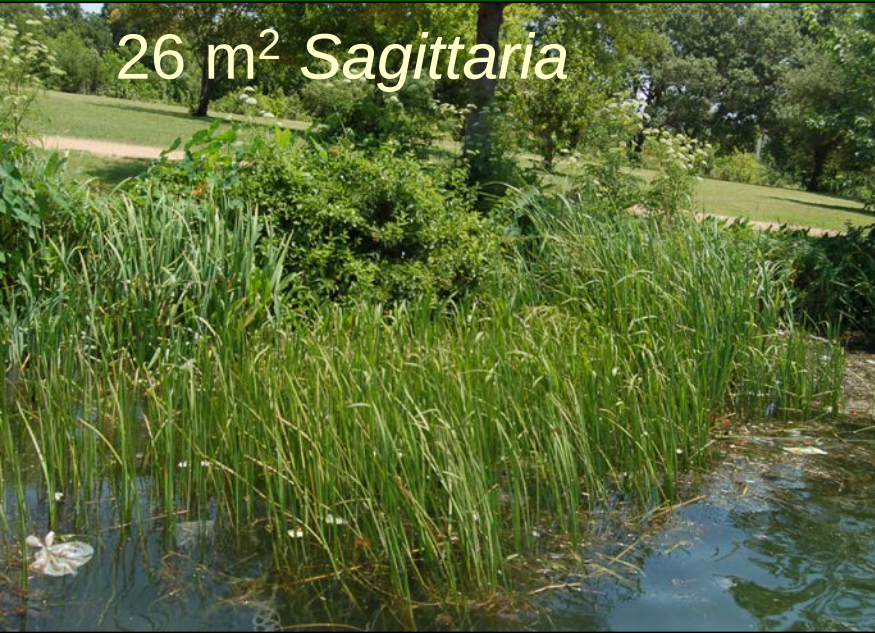
26 m<sup>2</sup> *Sagittaria*

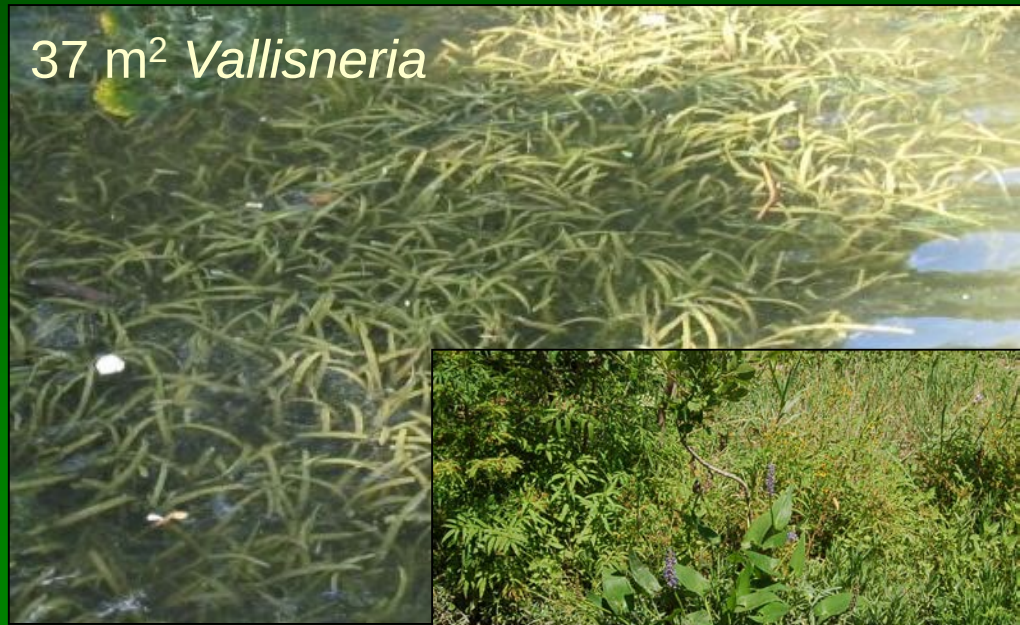
37 m<sup>2</sup> *Vallisneria*
