# Giant Salvinia Eradication in Evans County Georgia

# Evans County 2015

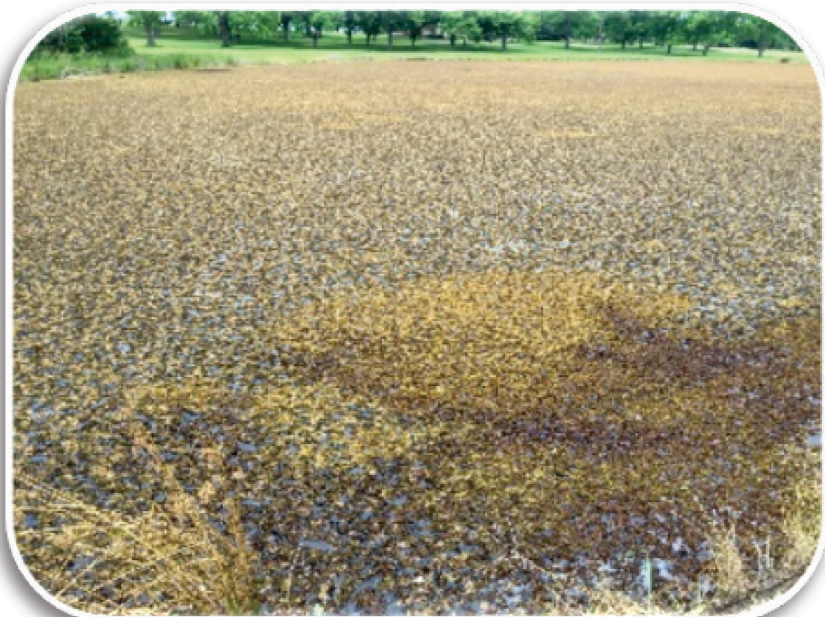
Strickland Pond  
Approximately 3 acres

- First reported in 2014 but was incorrectly identified
- Reported to GA DNR in January 2015

- Initial pond treatment of 40 ppb liquid Sonar and 30 ppb granular Sonar
- A 1% diquat solution has been used for all land applications and follow-up pond treatments

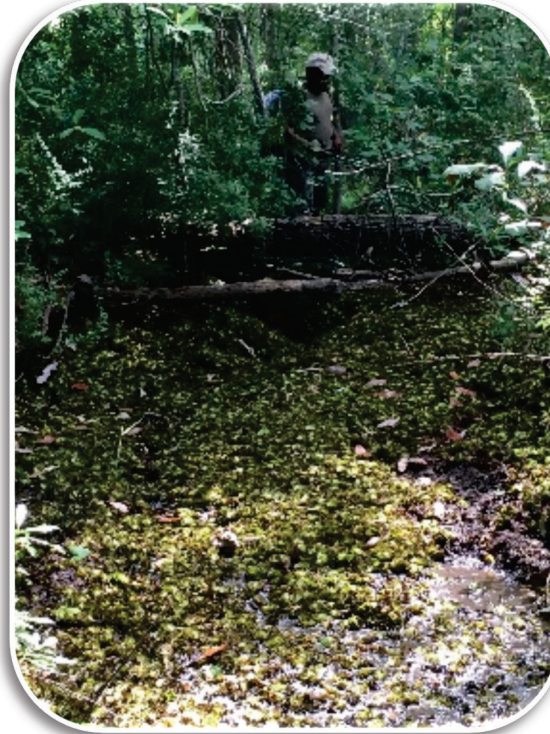
Access area into  
Mr. Sands property

- Cause of introduction still unknown
- Due to winter water temperatures and a wet spring, treatment didn't begin until April 2015

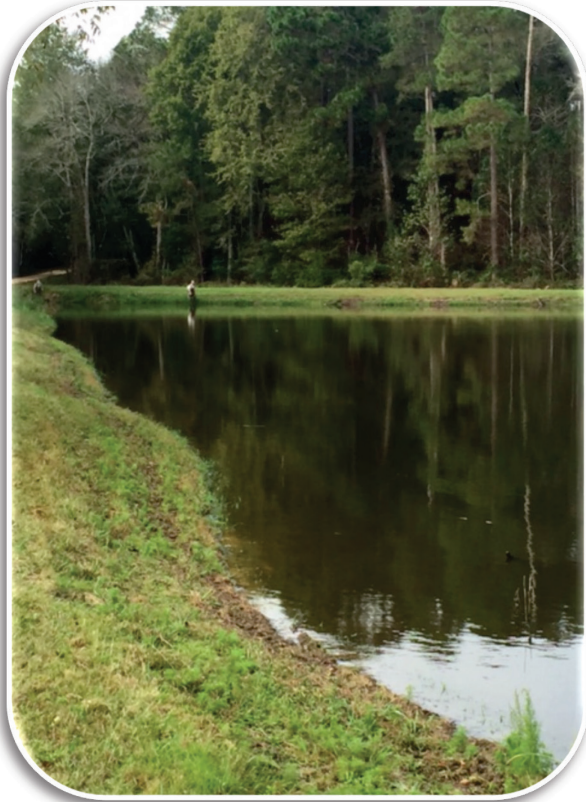
Strickland Pond

- Team has spent more than 300 hours on inspection and treatment
- Purchased more than \$2000.00 worth of chemical and equipment

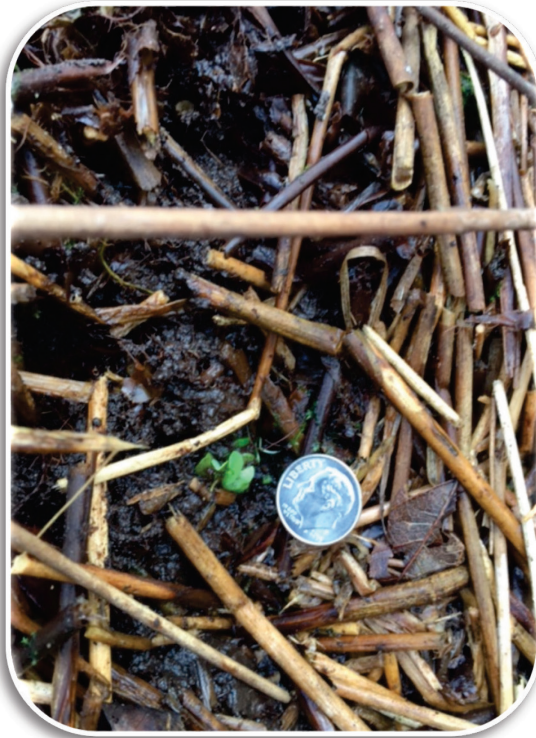
New growth deep within  
clumps of bulrush

- Conducting follow-up treatments every 3-4 weeks
- Continue to find new-growth plants
- Will continue follow-up treatments into 2017 to ensure 100% eradication

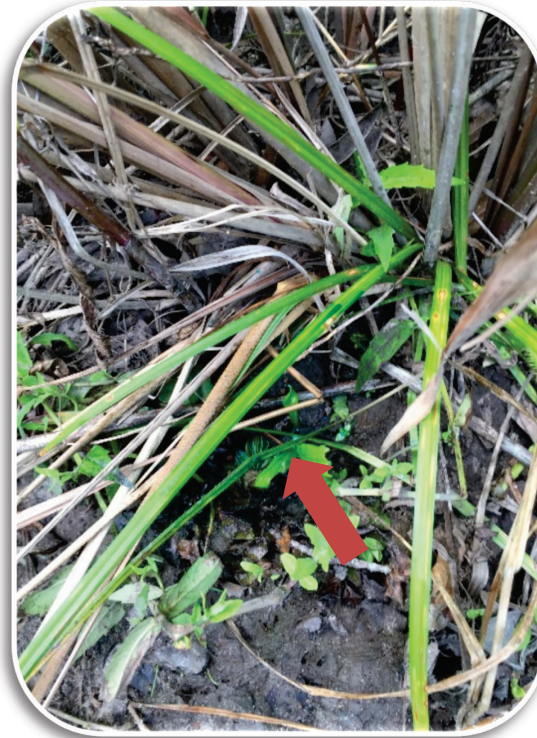
Small salvinia plants are  
hidden by terrestrial plants
