USGS Nonindigenous Aquatic Species Aquatic Risk Mapper (NAS ARM)

NAS FaST: a new tool to track the possible spread of nonindigenous aquatic species from flood waters of Hurricane Maria

Nonindigenous Aquatic Species Flood and Storm Tracker (NAS FaST) Maps

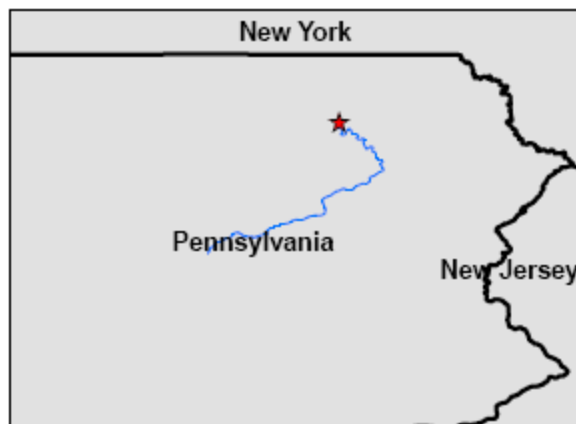
Specimen ID	1447224
Group	Mollusks-Bivalves
Genus	Dreissena
Species	polymorpha
Common Name	zebra mussel
Alert level	County: Wyoming (PA)
Alert Date	2/8/2018
State	PA
Locality	Susquehanna River
HUC8 Name	Upper Susquehanna-Tunkhannock
HUC8 Number	2050106
Collection Year	2017
Collection Month	2
Collection Day	8

Dam
-

Waterbodies at risk
-

Sighting location

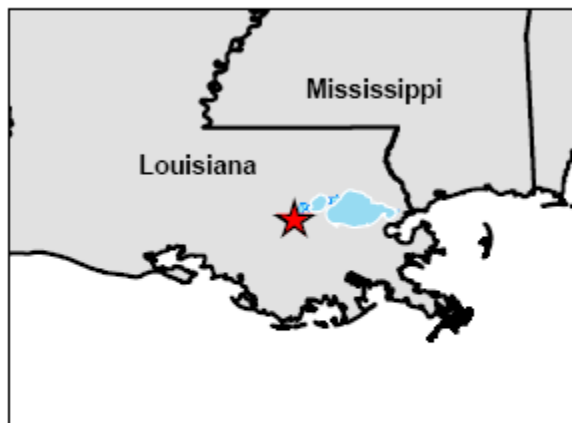
Specimen ID	1456478
Species	Nymphaea lotus (white Egyptian lotus)
Alert level	County: St. James (LA); Drainage: Lake Maurepas (8070204)
Alert Date	3/5/2018
State	Louisiana
Locality	Blind River, west of railroad tracks and Airline Hwy [61]
Latitude (N)	30.1032
Longitude (W)	-90.74466
Collection Date	11/4/2017

Sighting location

Waterbodies at risk

Reaches at risk

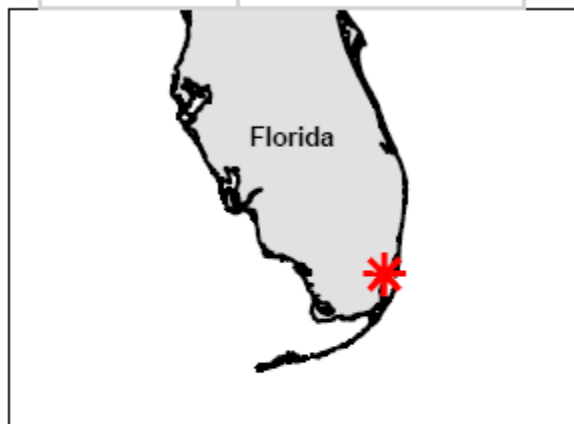
Specimen ID	1446927
Group	Fishes
Genus	Colossoma
Species	macropomum
Common Name	tambaqui
Alert level	County: Miami-Dade (FL)
Alert Date	2/6/2018
State	FL
Locality	Fuch's Pond
HUC8 Name	Florida Southeast Coast
HUC8 Number	3090206
Latitude	25.69591
Longitude	-80.29848
Collection Year	2017
Collection Month	8
Collection Day	11

Sighting location
-

200 m Buffer

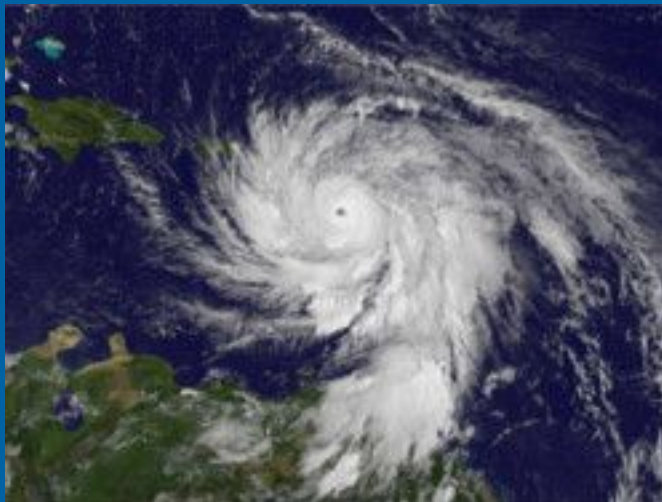
Stage 1
2-4 Days

Initial rapid response and the creation of a map of potential flooded HUCs. Maps will include information about NAS that could spread.

Stage 2
6-8 Weeks

Follow-up assessment of drainages that had flooding conditions that could breach drainage divides from coastal storm surge or inland flooding.

Stage 3
12-18 Months

Final review of which drainages were connected from flooding and any records of potential NAS transport due to coastal storm surge or inland flooding.
