Identifying Risks and Prescribing Access Enhancements

Aquatic Invasive Species Watercraft Access Analysis

Pilot: Risk Assessments + Site Prescriptions

Bureau of Land Management Project Report: L22AS00240

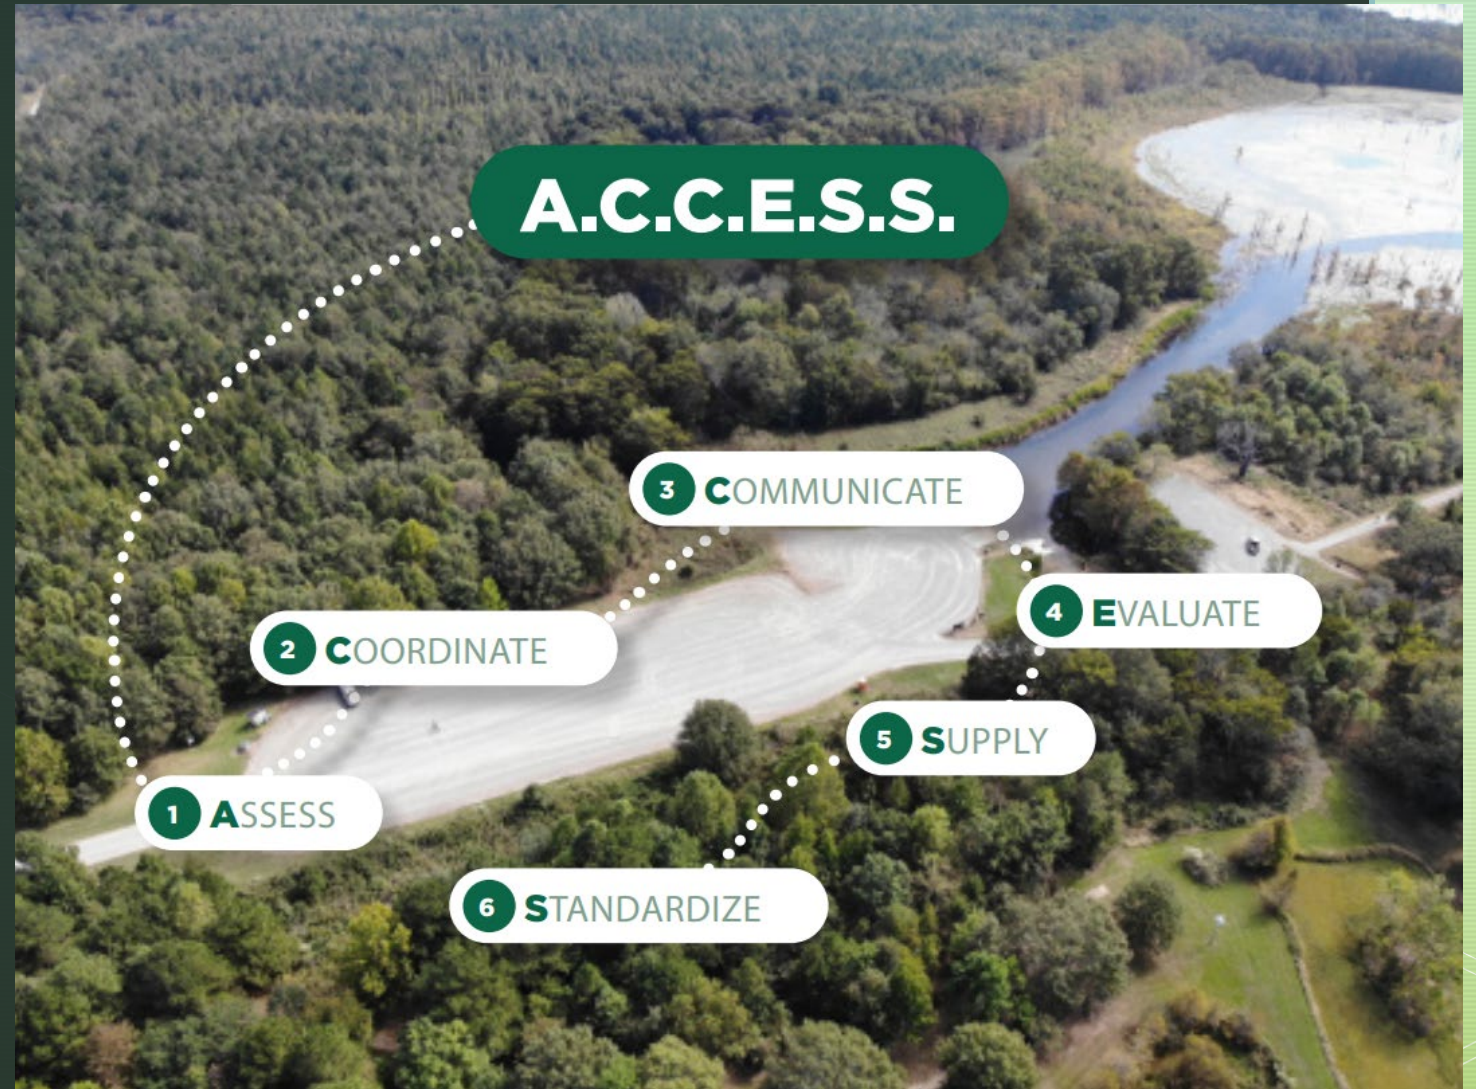
Black Bayou National Wildlife Refuge: Monroe, LA — Access Enhancement

Existing Site Features

- A** Reserved Parking Spaces
- B** Trailered boat launch (50 hp max)
- C** Canoe/kayak launch
- D** Walking pier parking lot

Recommendations

- 1** Install watercraft cleaning station near exit to promote outbound use without impeding inbound traffic.
- 2** Install stencil
- 3** Install enhanced signage with cohesive messaging

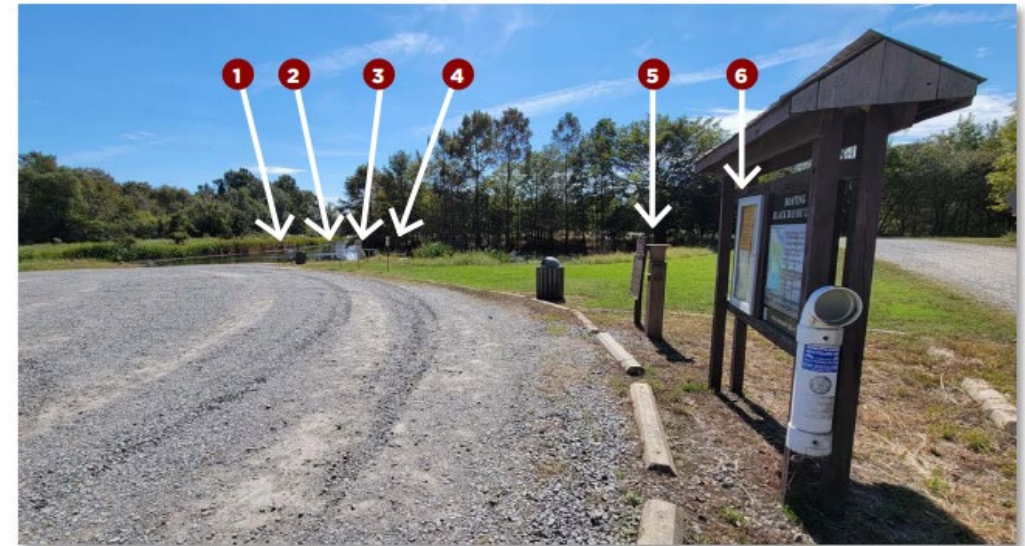
Current signage at the Refuge's public water access

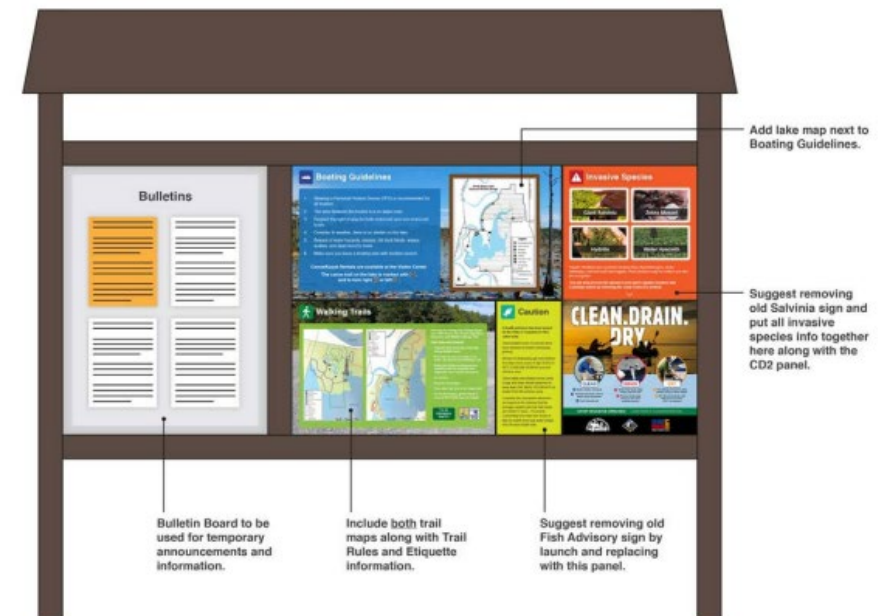
Recommended signage enhancement to provide cohesive and centralized messaging

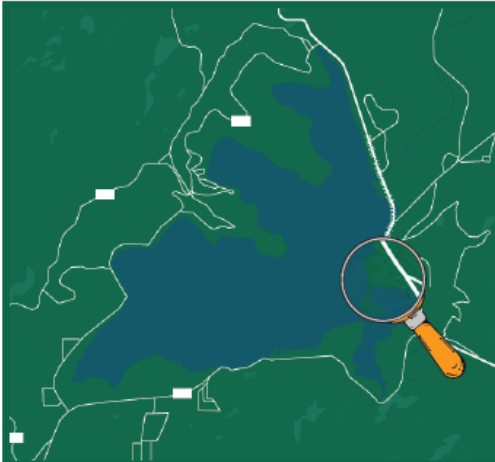
Grassy Point Picnic Area

Georgetown Lake is a heavily trafficked water body with six developed accesses. The lake faces a current infestation of Faucet Snail and nearby threats of Curly-leaf pondweed, New Zealand mud snail, and Parrotfeather. The access is located in a particularly weedy area and is the largest access on the lake.

KEY
 ● = boat ramp
 ● = signage (N/A)
 ● = trash receptacles
 ● = parking
 ← = inbound route
 → = outbound route

Access Checklist
Lot/ramp condition	<ul style="list-style-type: none"> asphalt ramp, concrete ramp good condition
Parking	<ul style="list-style-type: none"> 38 spaces
Existing Infrastructure	<ul style="list-style-type: none"> Trash Restroom NO AIS tools NO AIS signage
User demographics & activities	<ul style="list-style-type: none"> Motorized/non-motorized boats, shoreline anglers, tourist sightseers 45-55 white
Busy season	<ul style="list-style-type: none"> May thru Sept
Inspector/Decon?	<ul style="list-style-type: none"> None at access or surrounding areas
Flood prone?	<ul style="list-style-type: none"> No
Cell service/electricity?	<ul style="list-style-type: none"> Cell service, no electricity
Infested	<ul style="list-style-type: none"> Faucet snail present Threat of Curly-leaf pondweed, New Zealand mud snail, Parrotfeather found locally

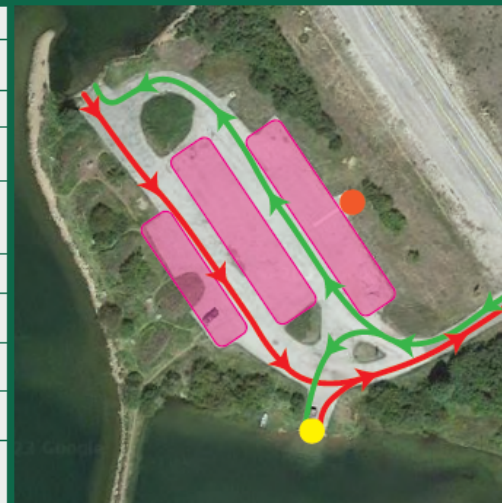
Grassy Point Picnic Area

Georgetown Lake is classified as: HIGH RISK

- Lack of prevention tools & signage
- Threat of outbound spread of Faucet snail, inbound spread of Curly-leaf pondweed, New Zealand mud snail, Parrotfeather

● = boat ramp
 ● = tools/equipment
 ● = signage
 ● = parking
 ← = inbound route
 → = outbound route

Watercraft cleaning equipment: Inbound/Outbound

- Solar powered Wayside cleaning station: CD3 systems
 - Clean Drain Dry wrap
 - Stop Invasive Species wrap
 - Everyone Likes a Clean Boat wrap
- Landing Station cleaning system: MAJK Solutions
 - Clean Drain Dry (Angler) sign

Signage: Inbound/Outbound

- Install Clean Drain Dry & educational signage at boat ramp entry
 - Risk Species: **Faucet snail, Curly-leaf pondweed, New Zealand mud snail, and Parrotfeather**
- Signage near watercraft cleaning equipment
- Clean Drain Dry stenciled pavement markings on concrete boat ramp

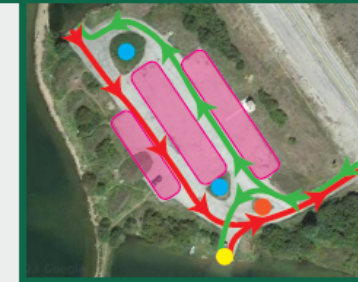
KEY

Access Recommendations:

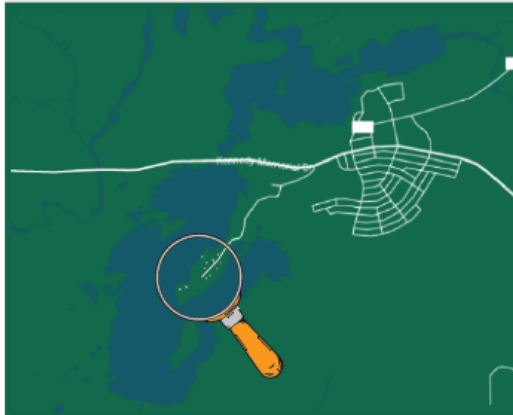
Whitewater Lake Public Water Access Site

KEY
 ● = boat ramp ● = signage
 ● = trash receptacles ○ = parking
 ← = inbound route → = outbound route

Access Checklist

of parking spaces (trailer) 6 (18)

Cleaning tools present None

of signs (AIS related) 11 (3)

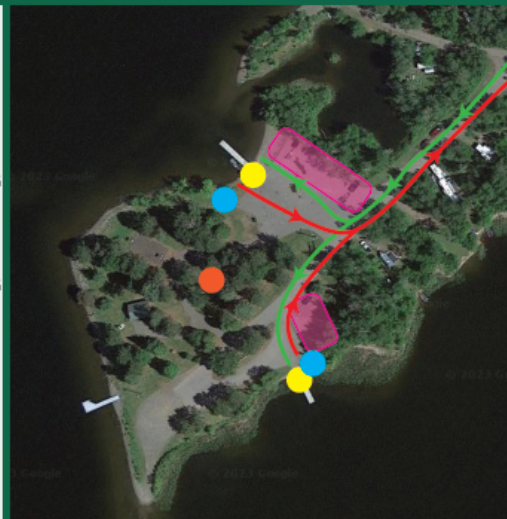
Whitewater Lake Public Water Access Site

Whitewater Lake is classified as: HIGH RISK

- High use access
- Several local infestations
- Limited access to mitigation

KEY
 ● = boat ramp ● = signage ← = inbound route
 ● = tools/equipment ○ = parking → = outbound route

Watercraft cleaning equipment:
Inbound/Outbound

- Solar powered Wayside cleaning system: CD3 Systems
- Clean Drain Dry wrap
- Aqua Weed Stick
- Extendable Brush
- Plug wrench
- Pressurized air hose
- Vacuum

Signage: Inbound/Outbound

- Install Clean Drain Dry & Educational signage at access entry
- Risk Species:
 - Chinese mystery snail, Curly-lead pondweed, Purple loosestrife
- Signage near watercraft cleaning equipment
- Describes how and why to use cleaning equipment
