# **One Invader, One Reservoir, 350,000 Reasons to Act**

A Presentation on Invasive Species and the threat to Our  
Drinking Water Supply

# Converse Reservoir (Big Creek Lake)

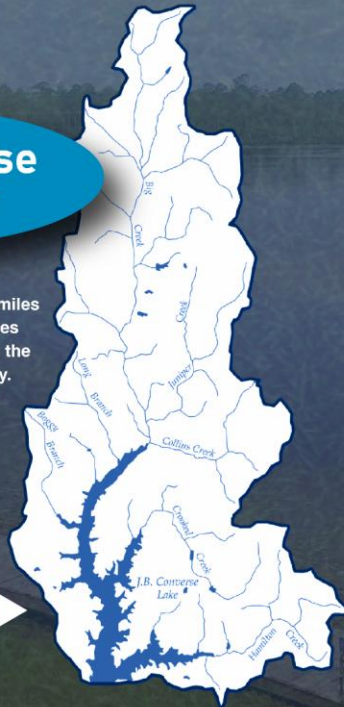
**MAWSS**  
Mobile Area Water & Sewer System

**J.B. Converse Dam**

**Buck's Pump Station**  
(Mobile River System)

**J.B. Converse Spillway**

**Saraland Reservoir & Pump Station**  
(Mobile River System)

**Gaillard Pump Station**  
(J.B. Converse)

**56 Miles of Pipeline**  
(J.B. Converse & Mobile River System)

**12 Flumes and 1 Aqueduct**

**42 Miles of Pipeline**

**11 Miles of Canals**

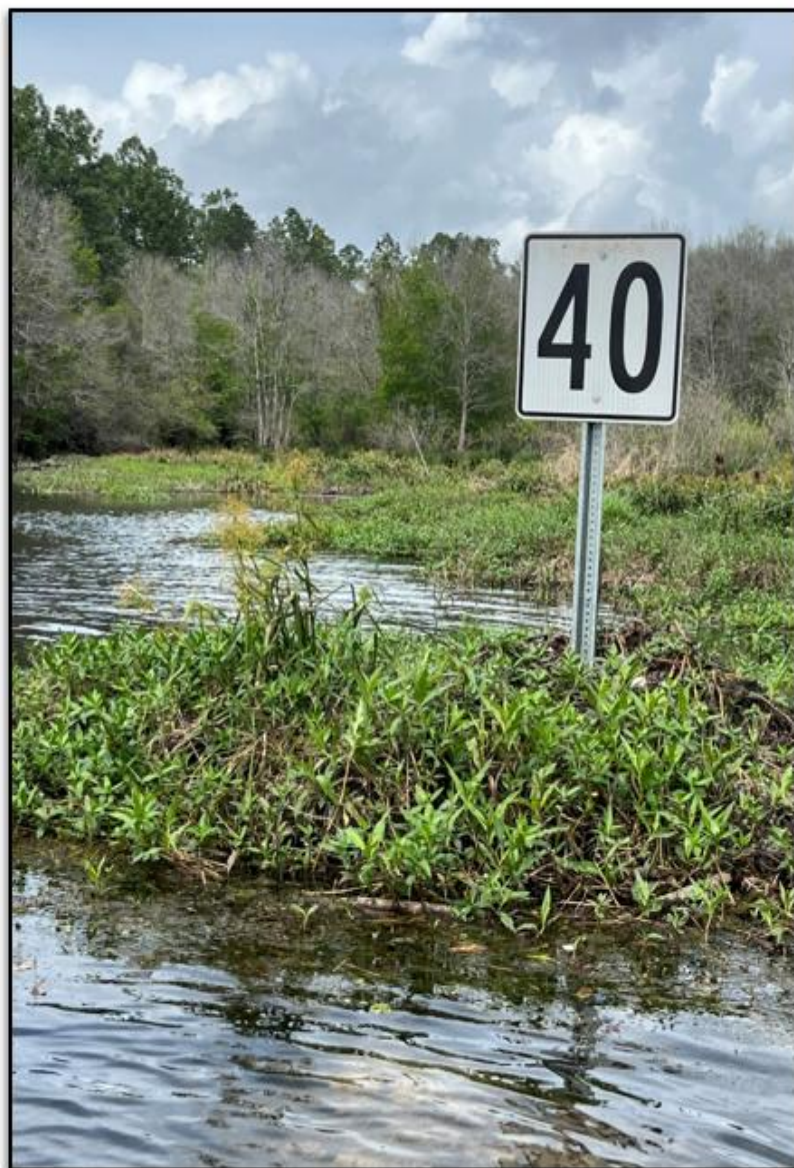
## 2026 SECOND QUARTER EXOTIC SPECIES MONITORING AT BIG CREEK LAKE

The second quarter exotic species monitoring of Big Creek Lake for 2026 was conducted on June 26<sup>th</sup> and 29<sup>th</sup> to document the presence of non-native Giant Salvinia (*Salvinia molesta*), Cuban Bulrush (*Cyperus blapharolentos*), and Pantropical Beakrush (*Rhynchospora corymbosa*). Seventy-one permanent monitoring stations were visited to estimate site-specific cover of the three species along with the mapping of incidental observations made between the stations. The following report provides the results of the second quarter monitoring effort and gives recommendations for the management of the exotic species.

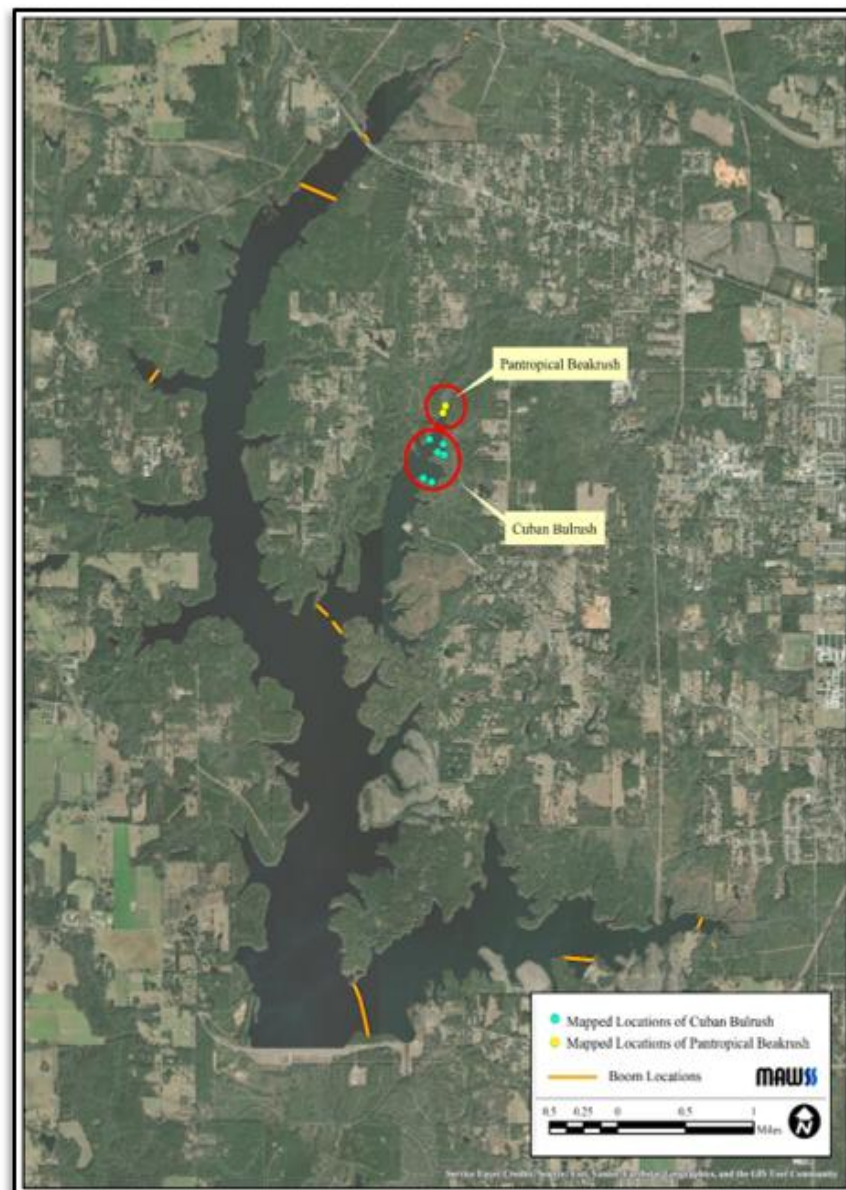
**Figure 4.** Mapped Occurrences of Cuban Bulrush and Pantropical Beakrush (June 2026)

Occurrences of Cuban Bulrush were limited to the head of Crooked Creek. Six incidental observations of the species were noted between stations 37 and 41 (**Figure 4**). Three observations of the species were made in the March assessment from the same general area.

Pantropical Beakrush was found at the head of Crooked Creek, where large number of plants persist around the general vicinity of Plot 40 (**Figure 4**). Evidence of herbicide treatment was noted at this location, but continued spraying is needed to control the species.

While the June 2026 assessment found fewer occurrences of Pantropical Beakrush, it is unknown whether this reduction is due to targeted treatment by the herbicide applicators, or an artifact of seasonality. The species flowers and fruits in early spring and dies back quickly making it difficult to observe later in the season.

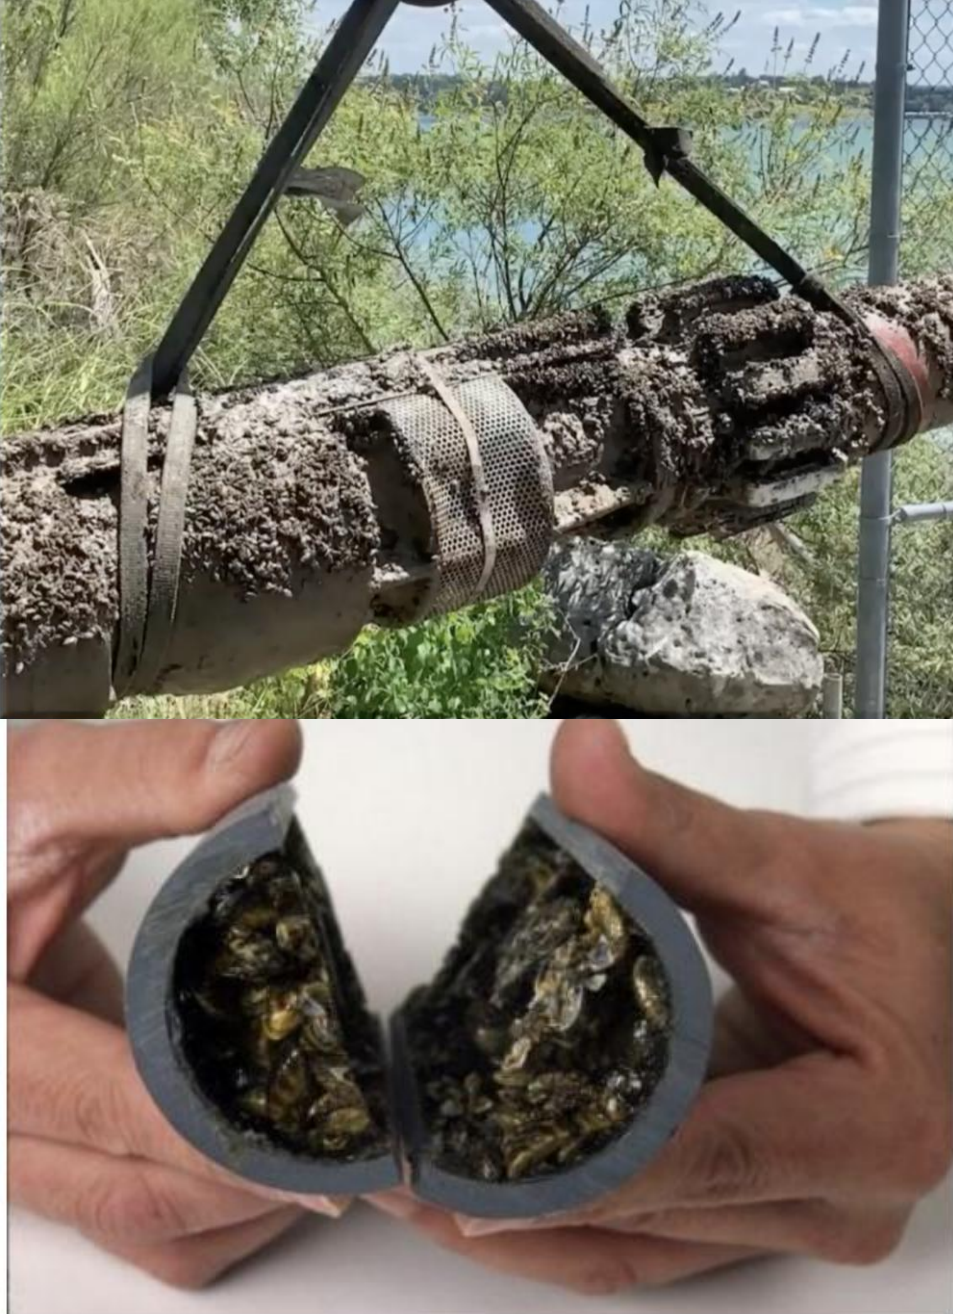
*Figure 2: Zebra Mussels in Small-Diameter Pipe  
(Source: Associated Press, 2014)*

- Zebra mussels clog pumps and pipes
- Cost more than \$1 billion annually to US water utilities – costs are borne by ratepayers
- Harm water quality and water pressure
- Nearly impossible to effectively clean boats
  - Drain boat
  - 140 degree wash of entire boat and trailer
  - Bleach on all soft surfaces
  - 2 week quarantine
